Docket No. 217 – Development and Management Plan Inspection

Northeast Utilities Service Company Certificate of Environmental Compatibility and Public Need for the construction of a 345-kV electric transmission line and reconstruction of an existing 115-kV electric transmission line between Connecticut Light and Power Company's Plumtree Substation in Bethel, through the towns of Redding, Weston, and Wilton, and to the Norwalk Substation in Norwalk, Connecticut.

Date: July 14, 2005

Location: 115 kV Underground Route

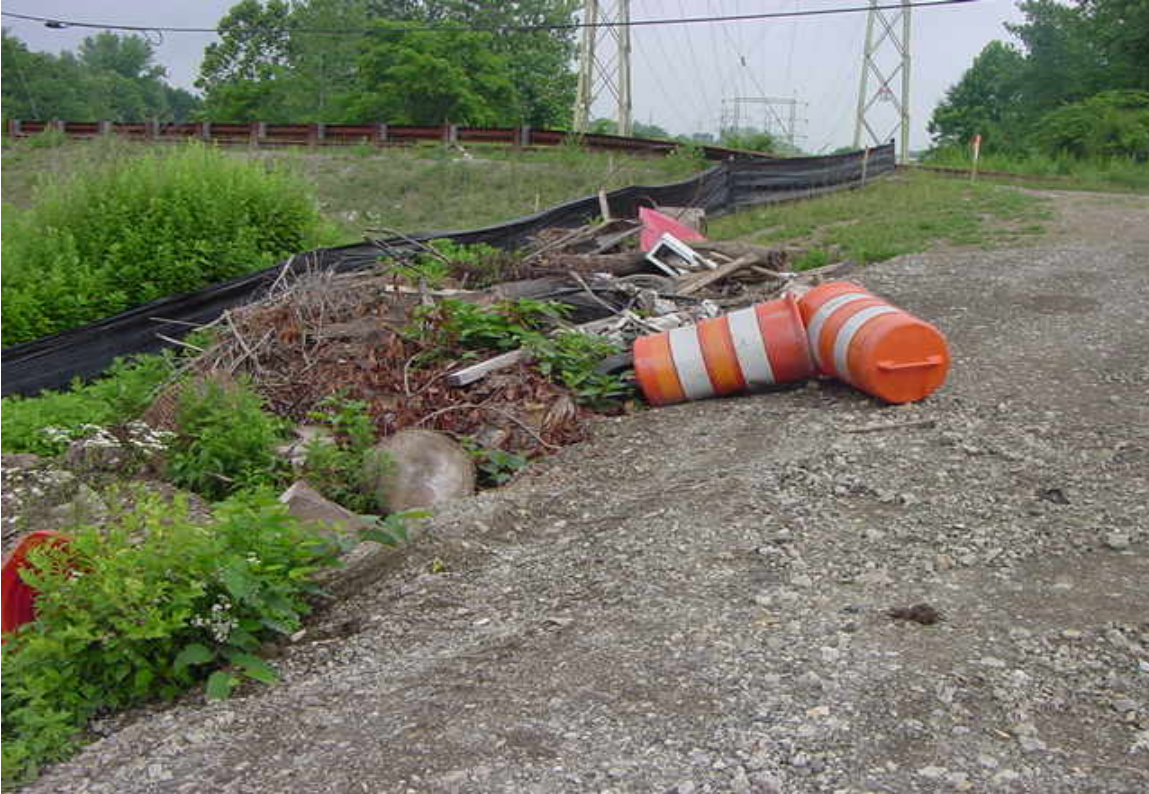
115 kV (Broad Street-Norwalk): A pile of debris and material near the silt fence that protects the area leading to the Norwalk River. (7/14/05)

Areas of Inspection	Observation	Recommended Action
Broad Street and Rt. 7 , Norwalk	<p>-The ductwork/installation has continued within Broad Street to the Rt. 7 overpass. Two vaults were installed in this general area. 7/14/05</p> <p>- Work along Rt. 7 has been suspended due to a tractor trailer accident earlier in the week. 7/14/05</p>	<p>-Activities are fairly well contained to the roadway however a few repairs should be made. See the erosion control section for more information. 7/14/05</p>
<p>Erosion and Sediment Controls (includes inspection within 24 hours of a storm event)</p> <p>Bethel Educational Park</p>	<p>- For the most part, silt fence has been well installed in all locations where the work is located adjacent to wetlands. 7/14/05</p> <p>- Stockpiles are not currently present for the most part. All excavated roadway material is currently being trucked off site for disposal or stored temporarily. 6/22-7/14/05</p>	<p>- Several areas still require maintenance or additional controls as soon as possible. Continue to be proactive in maintenance as necessary. See below for site-specific issues. 7/14/05</p>

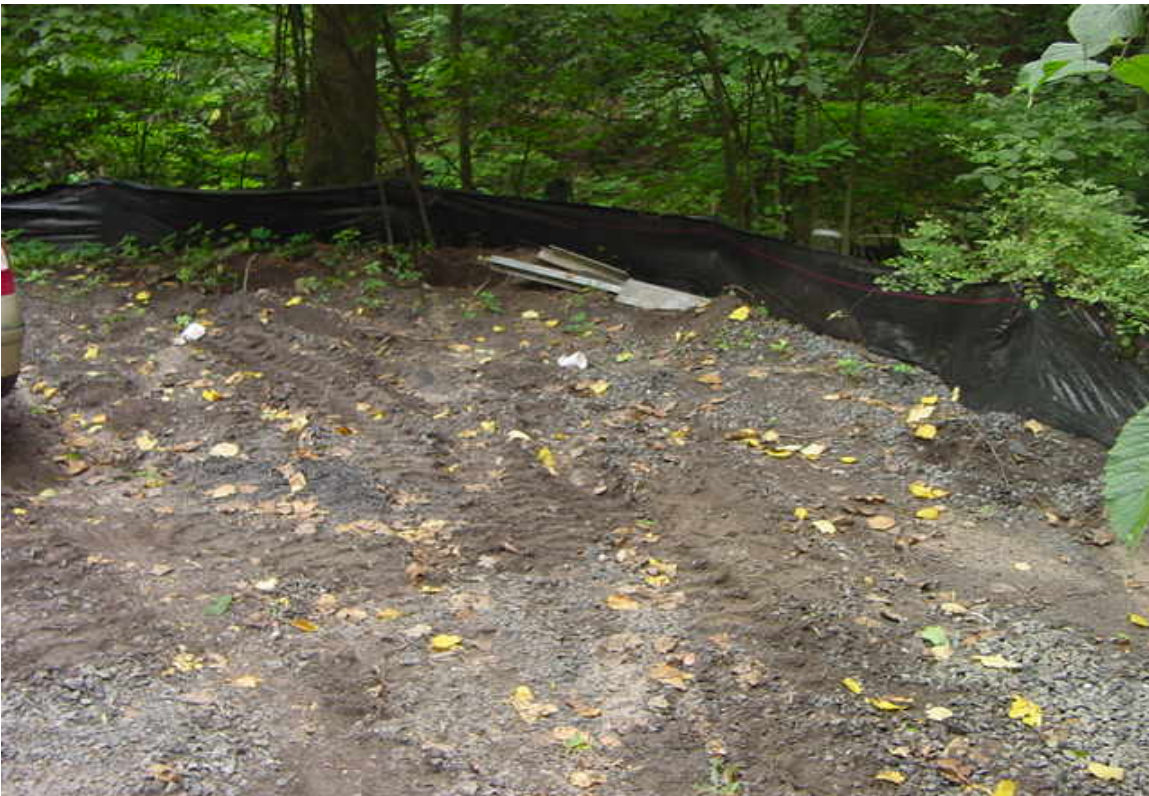
115 kV (Gallows Hill Road, Redding): Pull-off area in the vicinity of #116 Gallows Hill Road with loose stone and soil remaining. (7/14/05)

Staging, Storage, and Parking Areas	<ul style="list-style-type: none"> - The original pull-off on the side of Gallows Hill Rd still has silt fence is well in place but sediment has washed to the shoulder of the roadway where the fence does not cover. 7/6-7/14/05 - A second Gallows Hill pull-off near the completed vault #15 installation has some stone and loose soil stored here. 6/22-7/14/05 -Equipment and materials were not noted in the woods during this inspection. 7/14/05 - In Redding Town Yard, soil excavate is only temporarily stored here until it can be trucked for disposal in the O&G facility in 	<ul style="list-style-type: none"> - A check dam of fence or haybales should be extended to the roadway here. 7/6-7/14/05 - The area should be cleaned up when feasible, especially since sediment overtopped the adjacent roadway silt fence here. 7/6-7/14/05 - Equipment and materials should not be stored in wooded areas unless it is designated for storage. 7/14/05 - There are no current issues but if the piles progress beyond the bins, haybales should be placed

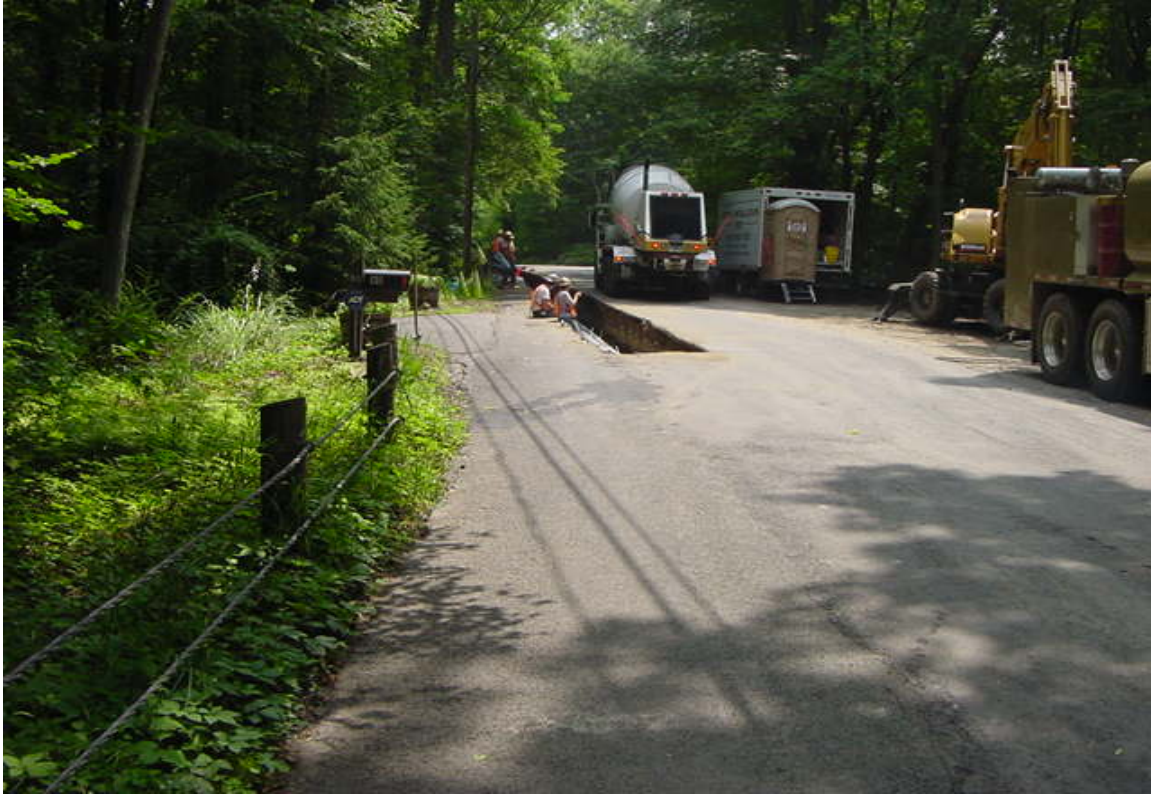
Floating concrete into the trench in the area of #80 Gallows Hill Road. (7/14/05)
Gallows Hill. Silt fence or haybales should be extended to the road. 7/6/05

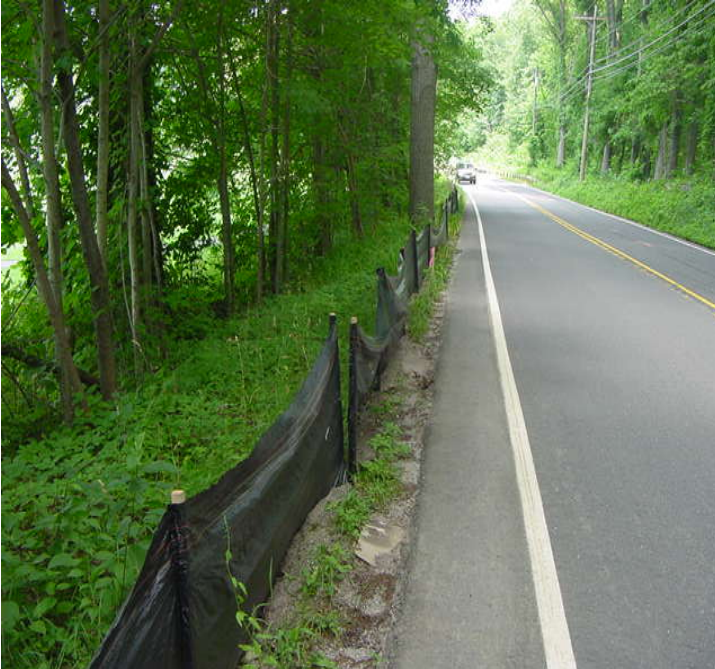
115 kV (Route 107, Redding)- Areas of silt fence
along Rt. 107 require maintenance in the vicinity of the Redding
Park. 7/14/05 Country Club. 7/14/05

Rt. 58 and Rt. 107 Putnam Park Road portion, Redding	<ul style="list-style-type: none"> - The silt fence in disrepair at the intersection of Rt. 58 and Rt. 107 belongs to the work at Putnam Park. The trench has not come through this area yet. 7/6-7/14/05. - An area of silt fence just before Putnam Park needs to be toed in properly. 7/14/05 	<ul style="list-style-type: none"> - None at this time. 7/6-7/14/05 -Silt fence should be maintained and toe in as necessary. 7/14/05

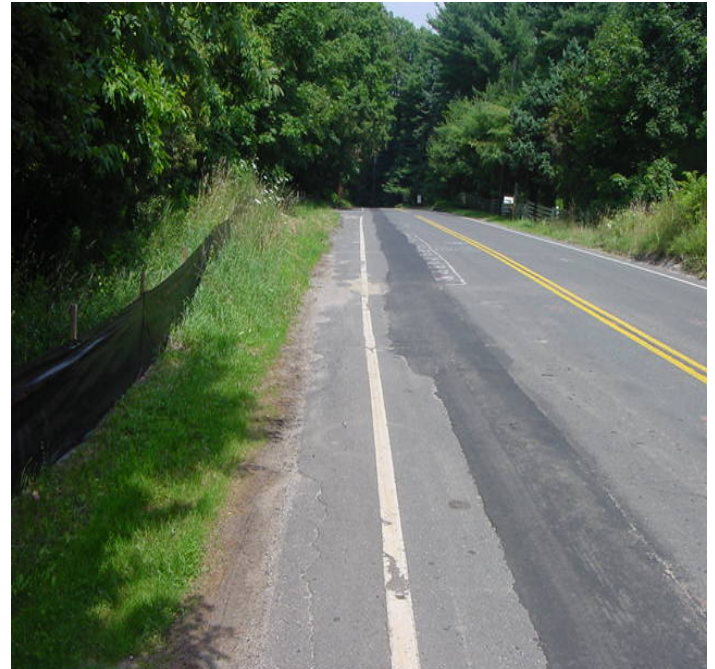
View of trenching and silt fence
north of Putnam

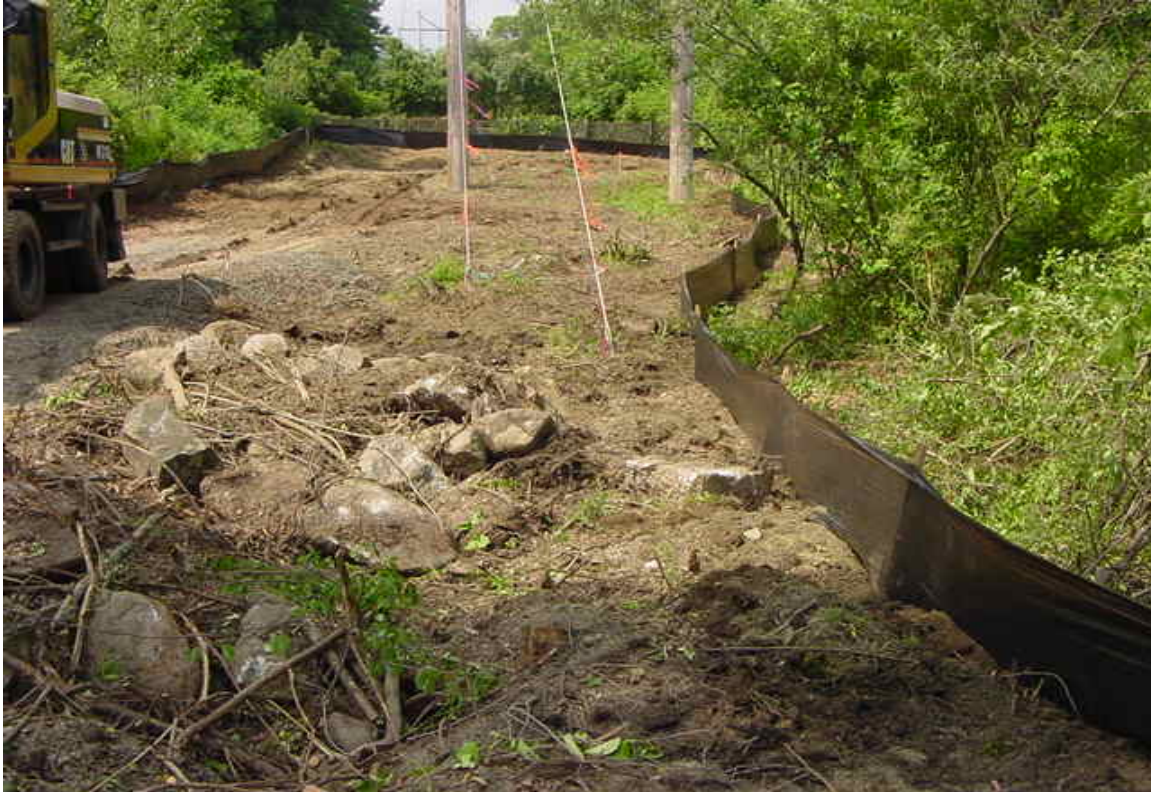
115kV (Hoyts Hill Road Transition): Silt fence along perimeter of clearing looking towards the location for the new transition structure. (7/14/05)

<p>- The pull-off leading to the transition station is fully cleared and a gravel access road has been built. Silt fence was being installed and toed-in along the entire access at this time. 7/14/05</p>	<p>- Maintain silt fence when necessary and avoid piling brush or chips into the adjacent wetland areas. 7/14/05</p>
Hoyts Hill Transition (Off Rt. 58)

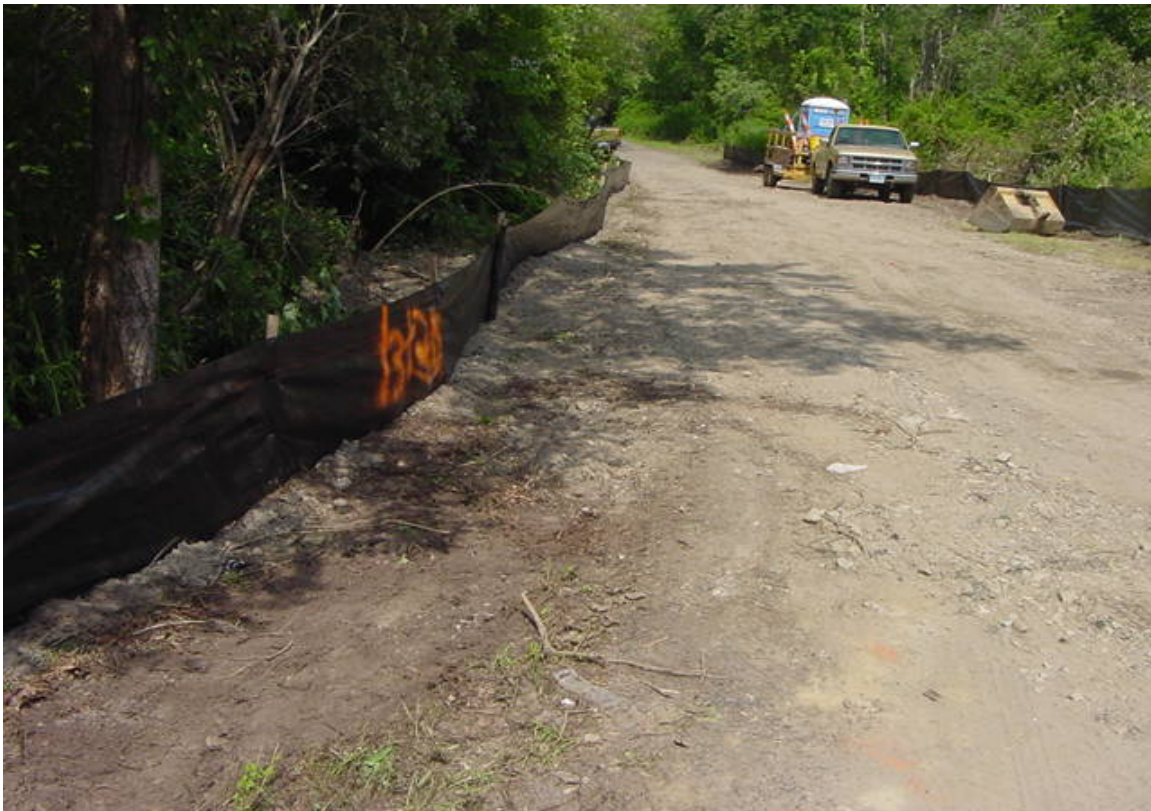
Silt fence along perimeter of clearing on the access into the structure location. (7/14/05)

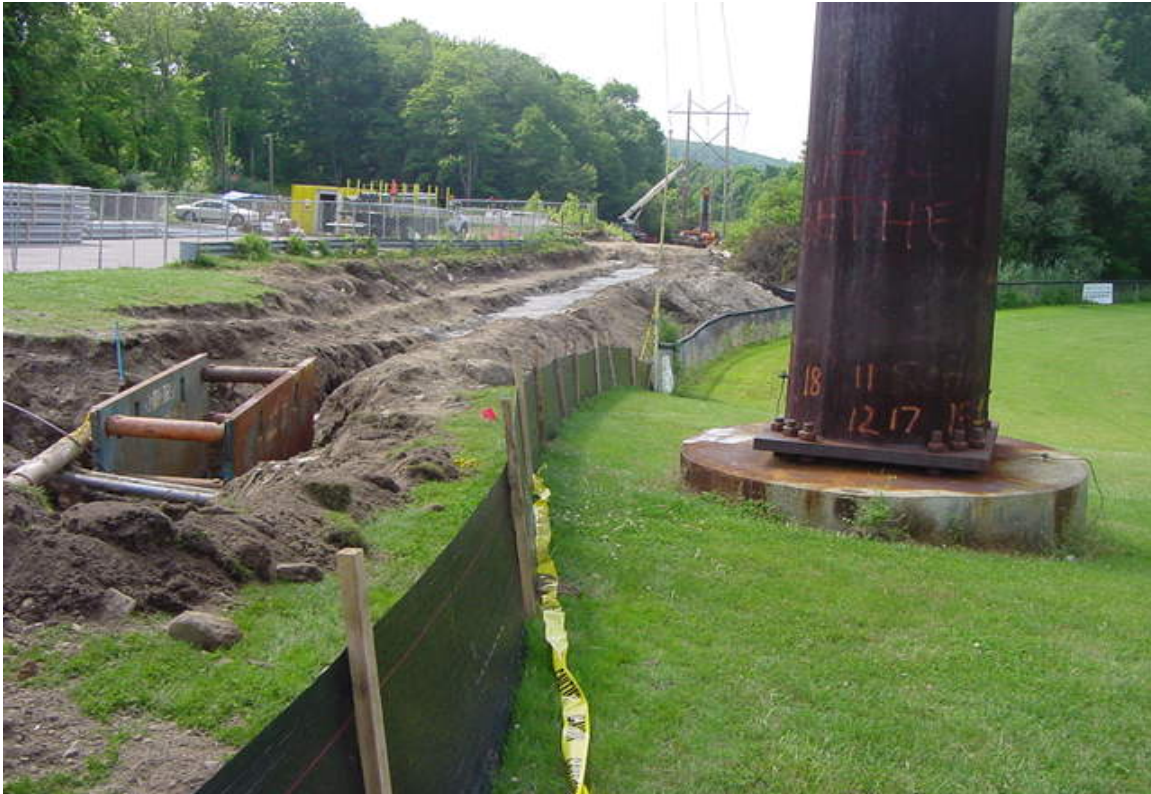
115kV (Bethel Educational Park): View of the ductwork installation near the RT Johnson School. The caisson drilling is occurring in the background. 7/14/05

<p>- Ductwork and caisson drilling is occurring near the RT Johnson School under the ROW. Silt fence is in place along the edge but the excavate is piled against it and has caused some strain. 7/14/05</p>	<p>- Keep the controls in good repair and pull back boulders or soil which may strain the fence. 7/14/05</p>
	<p>- Ductwork continues in the ROW near the Bethel Middle School. Silt fence was repaired here and should remain maintained due to the steep grade below. 7/14/05</p> <p>- The area cleared for the transition structure here could use additional silt fence (check dams) to prevent erosion down the grade. 7/6-7/14/05</p>	<p>- Continue to maintain and toe in silt fence when necessary to prevent any sedimentation outside of the ROW. 7/14/05</p> <p>- Install a check dam of silt fence across the top of grade on the larger cleared area to prevent erosion when the active work approaches. 7/14/05</p>

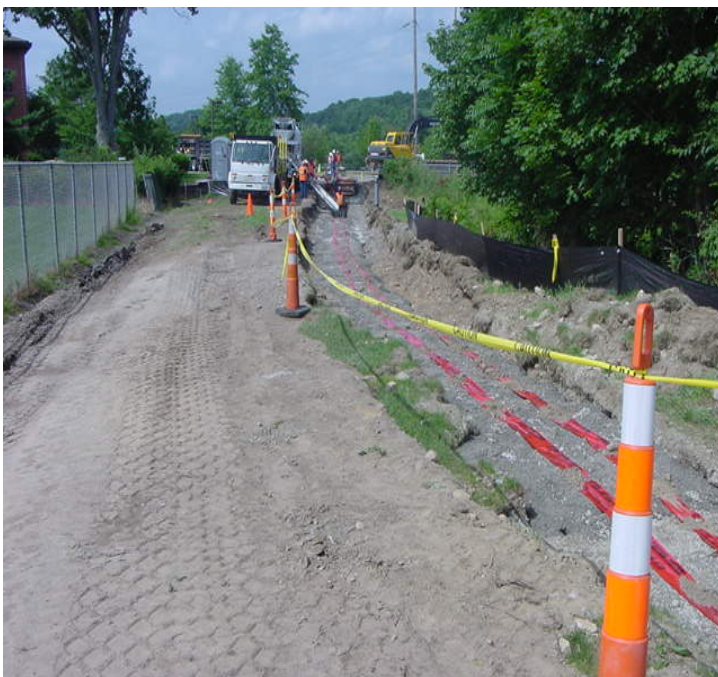
View of the floating in concrete in the trench ROW near the Bethel Middle School. alternate direction. 7/14/05

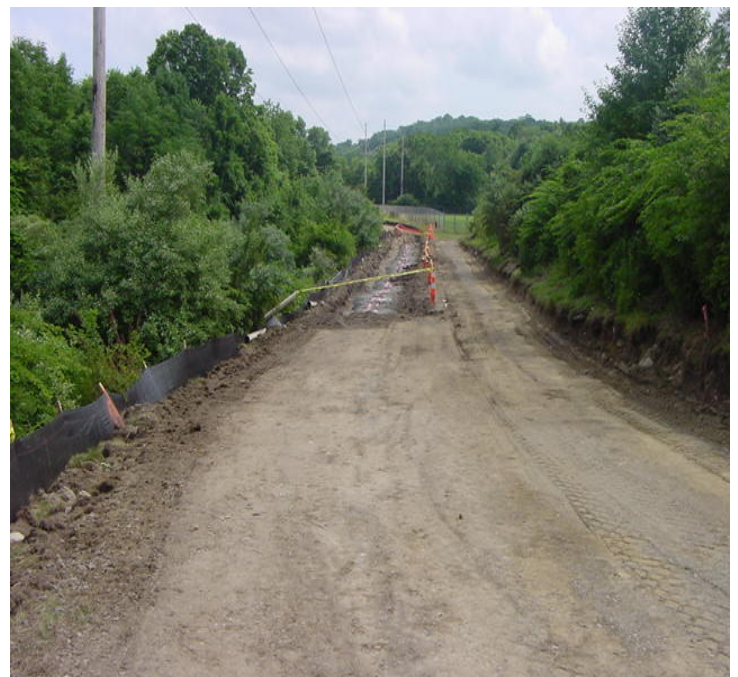
View of the trenchwork within the ROW within the Near the Middle School from an 7/14/05.
